# **Confocal Microscopy Studies for Plasma Surface Modified Films and Fibers**

**by Donovan Harris and Daphne Pappas**

**ARL-TR-4004**

**December 2006**

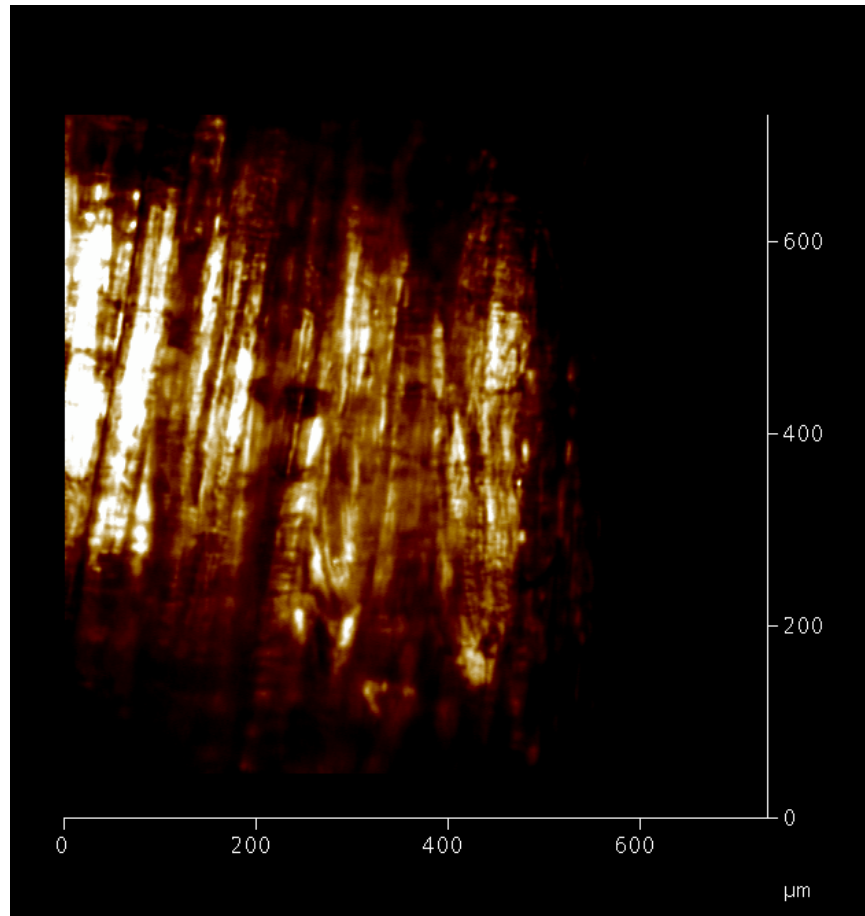
Figure 1. A section of Spectra woven fabric captured by the Nanoscope focusing camera. The camera is zoomed out to allow for rapid searching of the whole weave and for selection and alignment on a single fiber for analysis.

AFM scans of the woven Spectra fabrics were performed in tapping mode using a tip with a nominal radius of 10 nm. This style of tip had worked well on glass fiber tows to measure the roughness differences among sizing treatments of woven mats. The plasma treatment of the weaves dictated using the full sample and not extracting tows for examination. An image of the weave crest of a single tow captured by the AFM camera at minimum magnification is shown in figure 1.

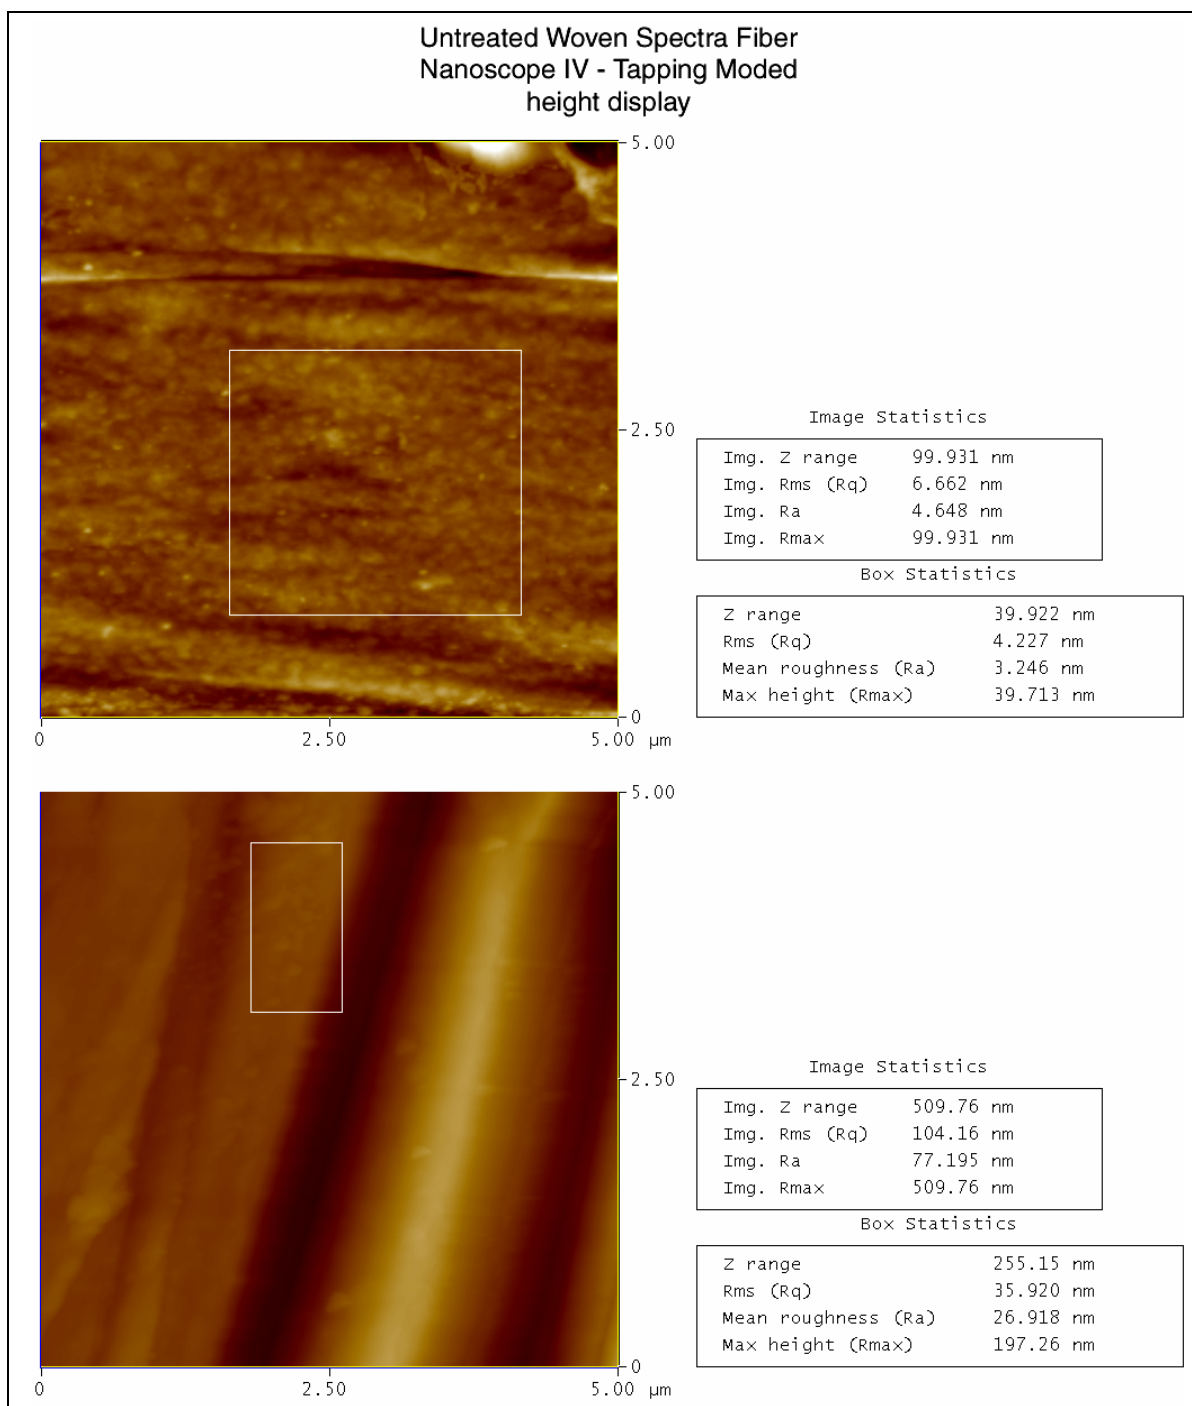
Figure 2. Two AFM height micrographs with roughness data of woven Spectra fabric fibers. (The micrographs were collected prior to any known camera issues.)

The measurements were made using only the top-most fibers to avoid any possible interactions between the counter lever and adjacent fibers. The first results appeared to be good, as illustrated in figure 2.

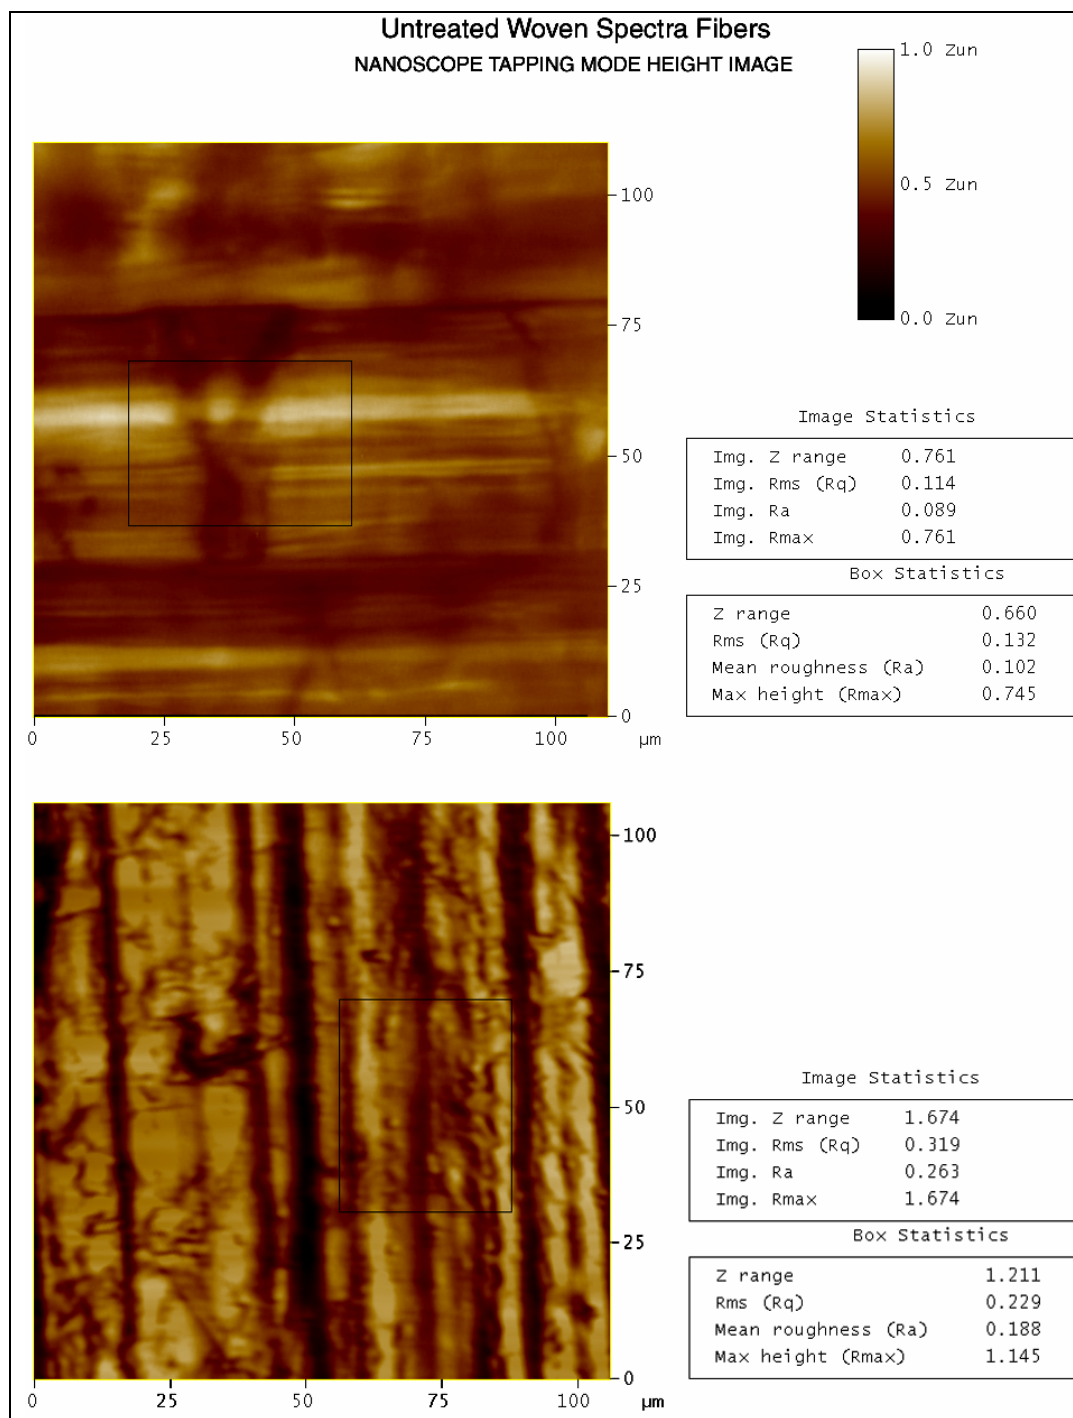
Figure 3. Two AFM height micrographs showing the progression of effects caused by the loosening of the camera. The lack of any scale values, shown in the bottom micrograph, was the first indication of a problem. In the top micrograph, the image quality and data analysis are clearly affected.

Figure 3 shows the first indications of the camera problem with the AFM. The nature of the problem was unclear at the time and unresolved until a service technician examined the system.

The loose lock washer caused the camera zoom lens to remain at an arbitrary position between full in and full out, producing a false Z value for the interval between tip focus and surface focus. While it was possible to image, the results were nonsensical, e.g., Z $\mu$ n. It became impossible to engage the tip. The Zeiss confocal laser scanning microscope was used with the nylon film samples until the AFM was repaired.

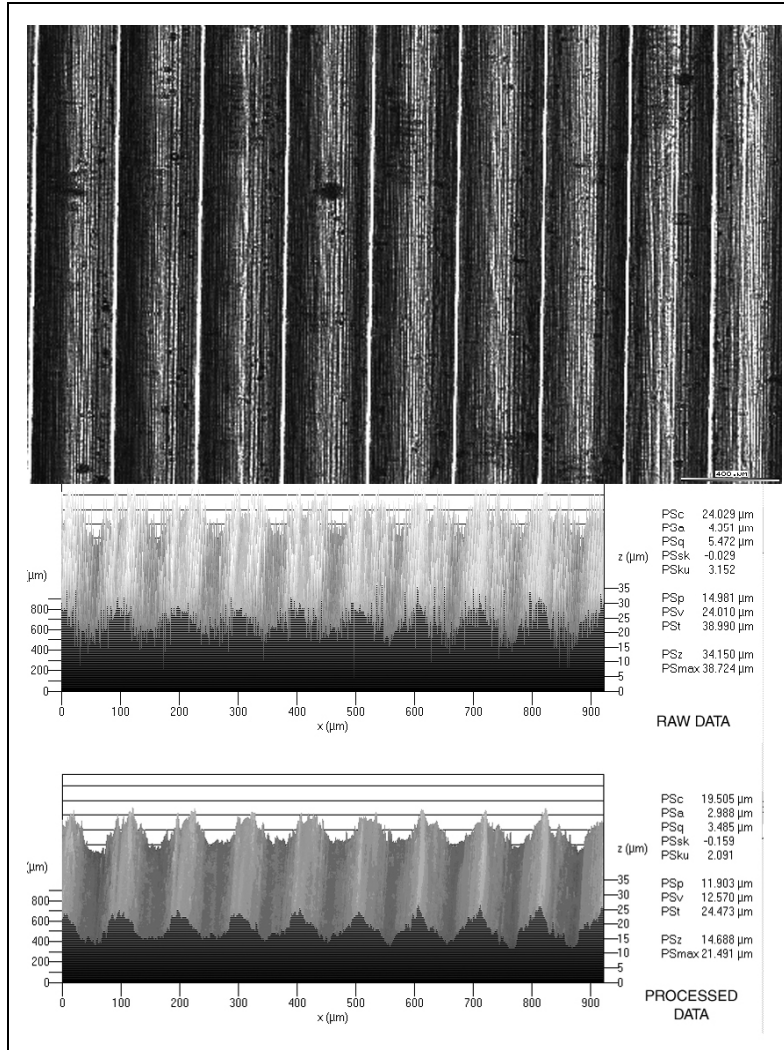
Figure 4. The top image is a two-dimensional (2-D) extended focus of an NIST sinusoidal roughness standard. The lower two images are 3-D visualizations with roughness values of the Z-stack data subjected to two different analysis criteria. The change in parameters affects the appearance of the visualizations and the roughness values.

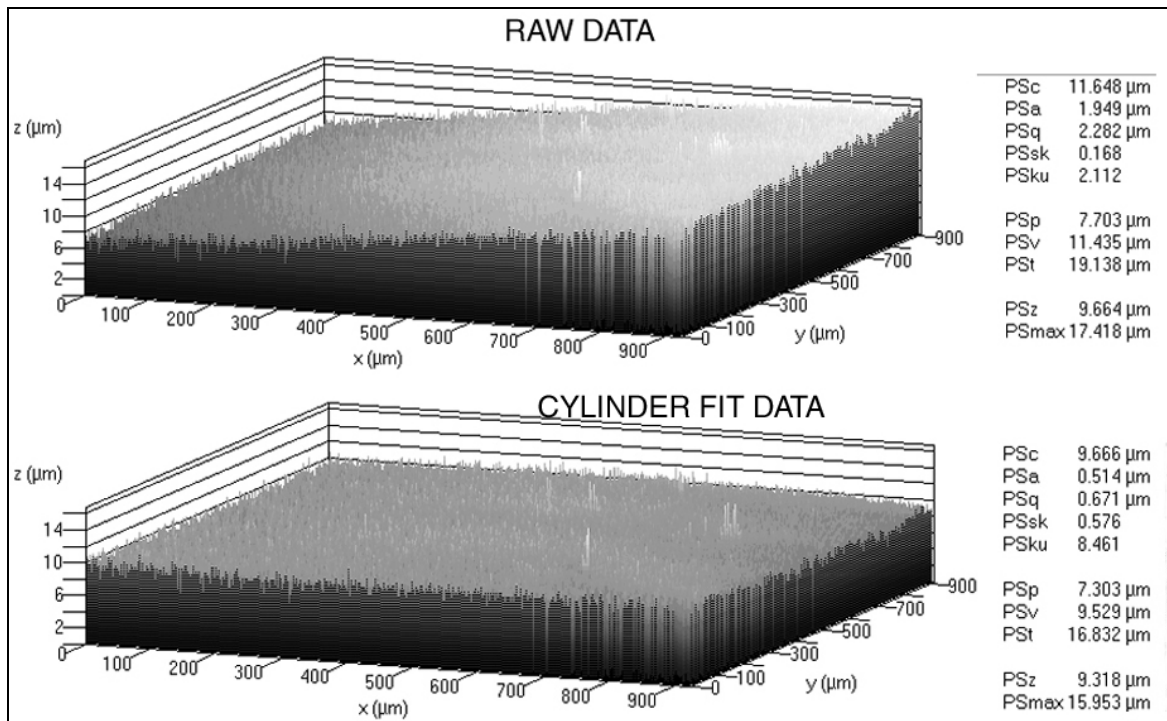
Figure 5. Three-dimensional visualizations illustrating the effects of “plane fitting” on the appearance of those visualizations and the apparent surface roughness of the Nylon 6 film.

Fastened only at the ends, the film samples in figure 5 bowed. Efforts to use an adhesive covering the entire underside and flatten the specimen were unsuccessful; however, applying the “Cylinder Fit” function in place of the “Plane Fit” corrected the problem.

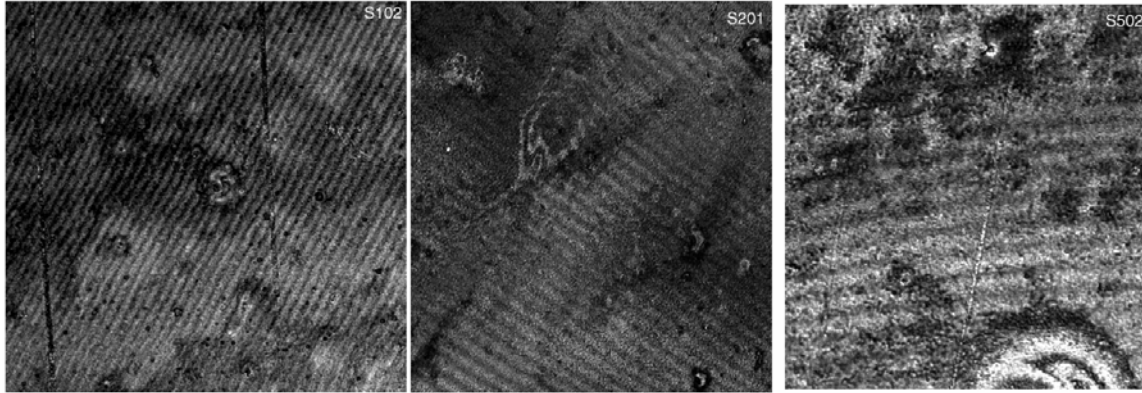
Figure 6. Three 2-D extended focus micrographs taken of nearly adjacent areas of the same Nylon 6 film. Notice that the parallel ridge-like features change direction, size, and radius of curvature from location to location. Because the only repositioning of the sample was done using the x-y stage controls, it is unlikely that those features are real.

The 2-D extended focus surfaces shown in figure 6 contain a series of apparent ridges similar to those of the roughness standard shown earlier. Initially, they were identified as machining scores generated at the time of manufacture, but comparing adjacent areas proved that could not be the case. The specimen has a single orientation for all the Z-stacks collected—how could machine lines change direction? The most probable explanation is that the film bow caused the generation of those ridges. Figure 7 illustrates how the bowing of the nylon film sample would generate the ridge lines.

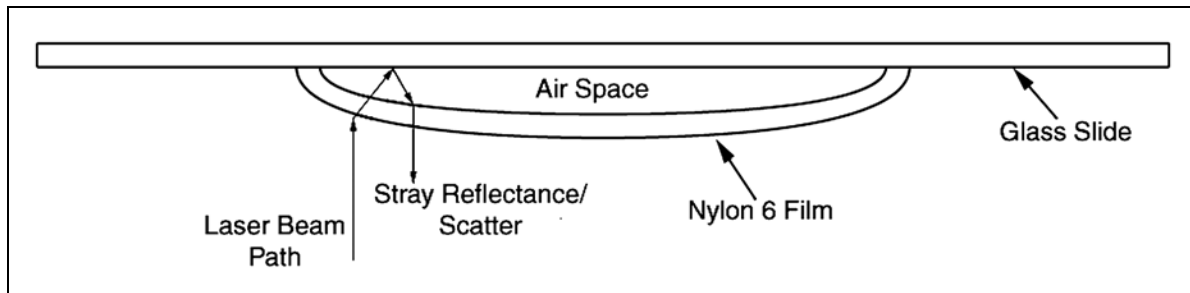
Figure 7. Diagram illustrating the most likely source of the ridge structures presented in figure 6.

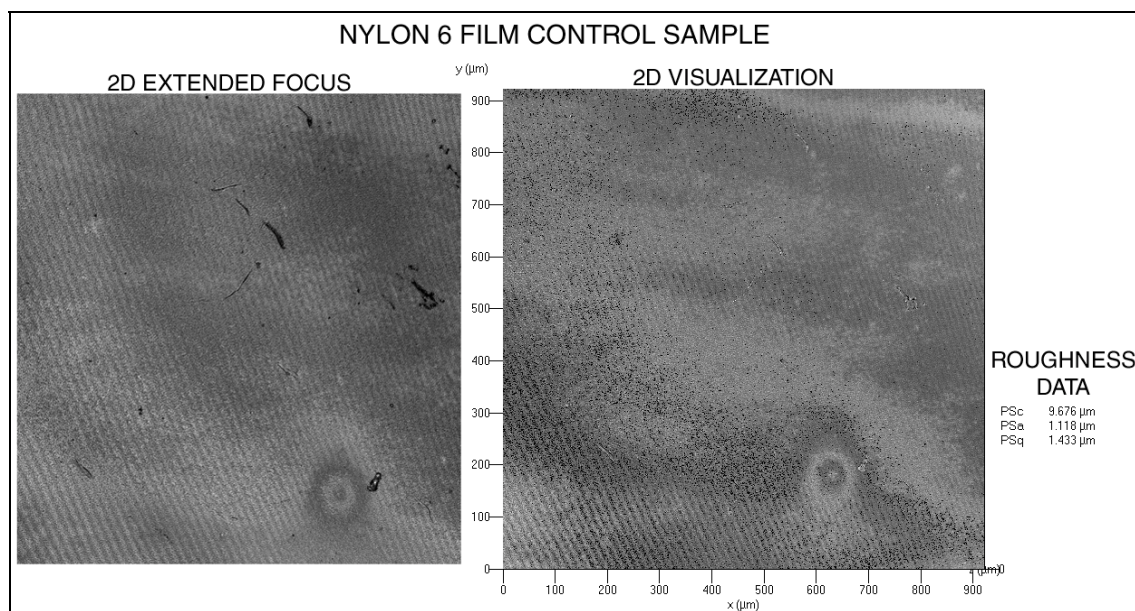
Figure 8. The left image shows a 2-D extended focus micrograph of a Nylon 6 film surface and the right, a 3-D visualization of that same data set. The visualization has been rotated so the Z-axis extends up out of the plane of the paper. The two are similar in appearance but not identical.

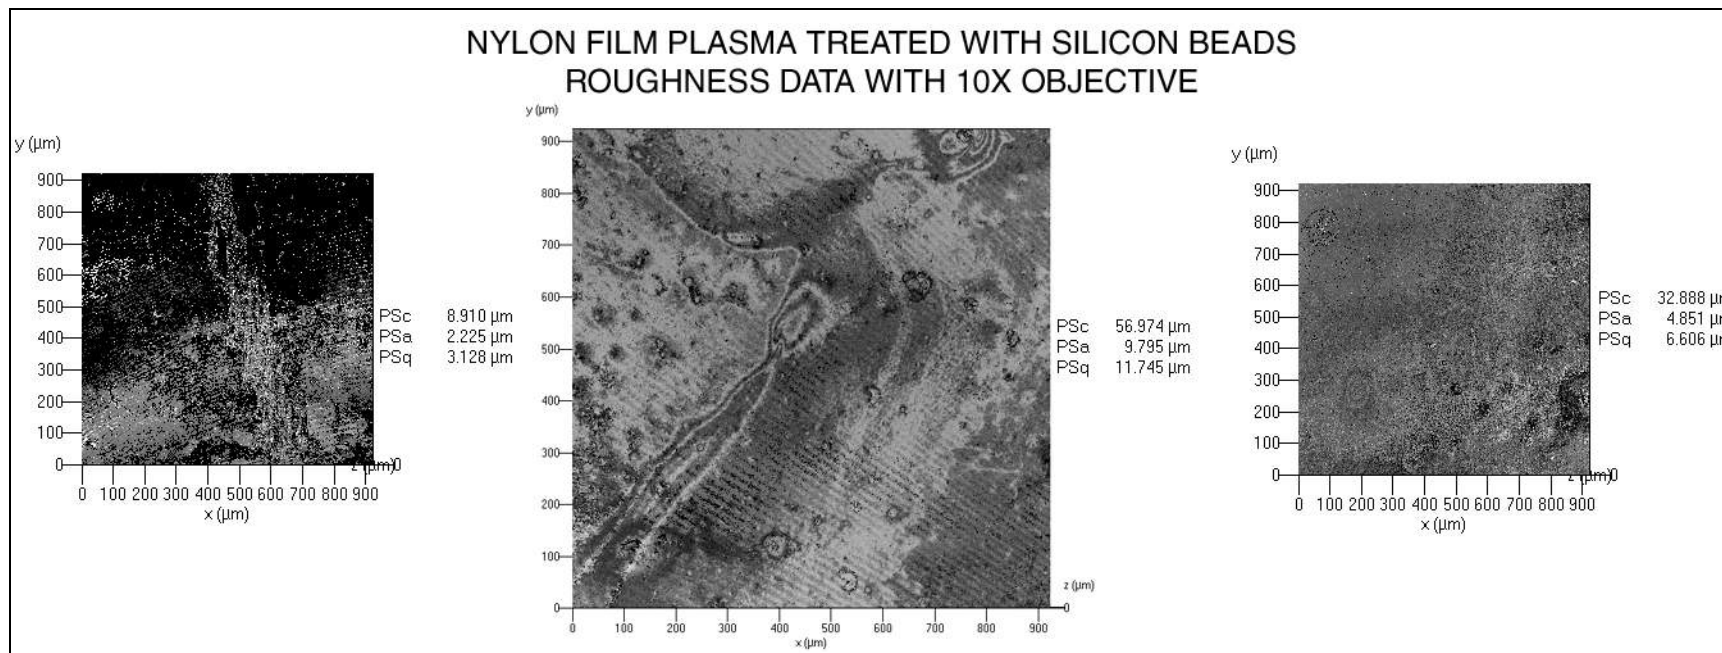
Figure 9. Three extended focus micrographs from the same plasma treated Nylon 6 film, at different locations.

The large variation of the silicon-bead plasma treatment roughness data is reflected in the Z-stack visualizations showing a surface transformed to a series of heterogeneous zones by the plasma process. One series of adjacent zones and the accompanying changes in surface roughness is presented in figure 9.

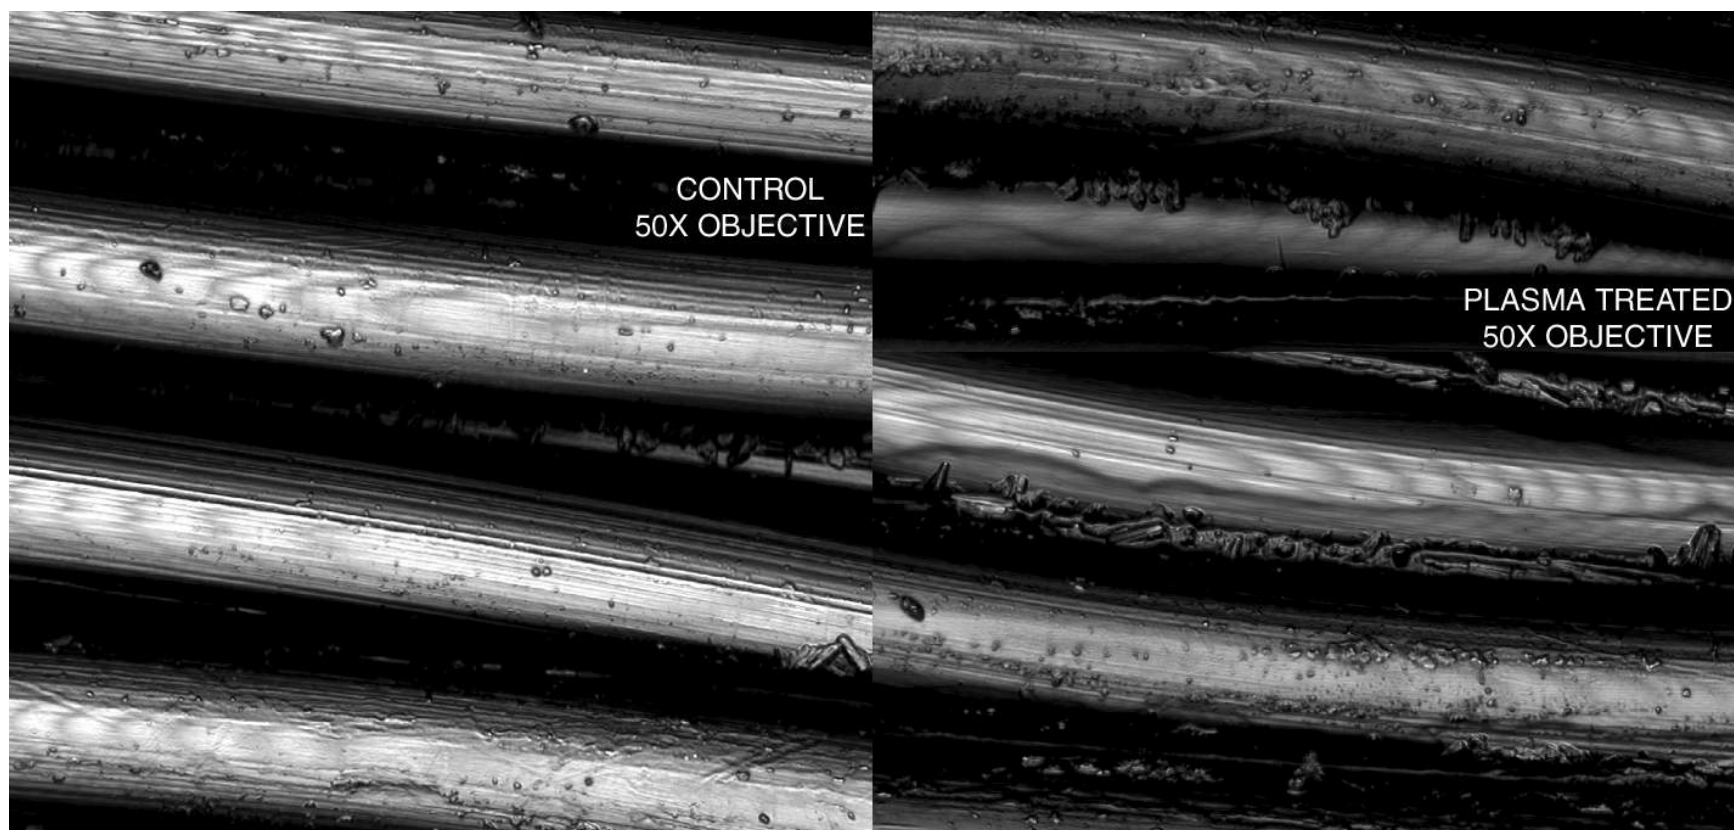
Figure 10. Comparison of the appearances between untreated and treated woven Nylon 6 fabric fibers. The chevron-like features are artifacts from the Z-stack processing. The clarity of the details provided the impetus to attempt using the confocal LSM for roughness measurements of these samples.

Based upon the LSM roughness results with the films, using the LSM to measure changes in the surface roughness of woven fibers was attempted. The initial raw data appeared promising, as illustrated by the two Z-stack extended focus images in figure 10.

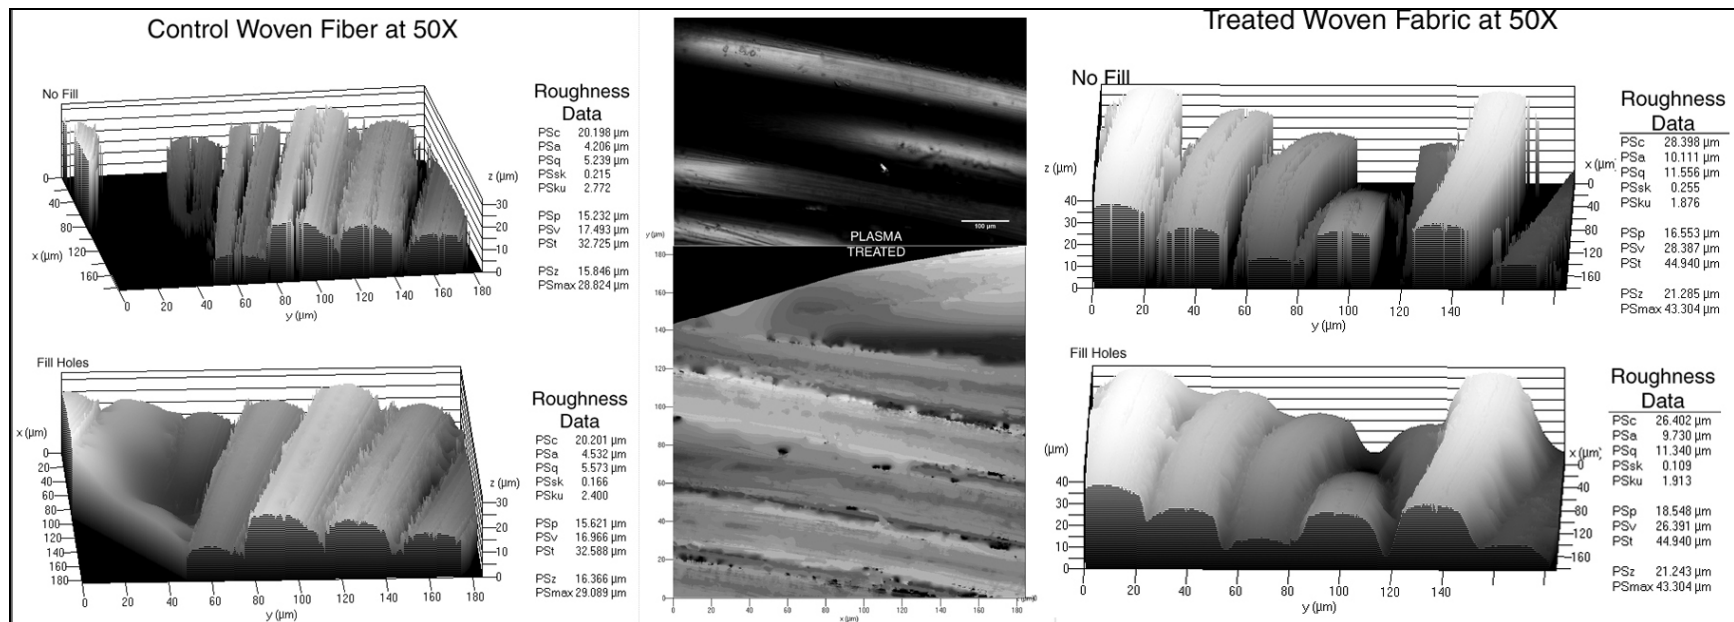
Figure 11. Five 3-D visualizations and the one extended focus micrograph, top center, illustrate one problem with producing roughness values from the fabric Z-stacks, defining a reliable reference plane.

The visualizations in figure 11 show the processed data used for the roughness determinations, which do not approximate the actual surface. The upper left and right visualizations were generated using the same analysis parameters as for the nylon films. The resultant images have significant void areas. Using the “Fill Holes” function in the analysis software corrects the voids problem but generates additional features and changes the roughness data. The obvious solution would have been to crop the stack along the length of any single fiber. The post-processing software only allows a user to define rectangle extraction from the stack without any rotation. Only the capture software allows for rotation during the Z-stack generation process. Attempting to derive an analysis technique using the available functions without the AFM for support appeared to be an open-ended effort. Because the AFM repair was only 2 weeks away, these analyses were not rerun.
